Report LR 1750 Roll-lift

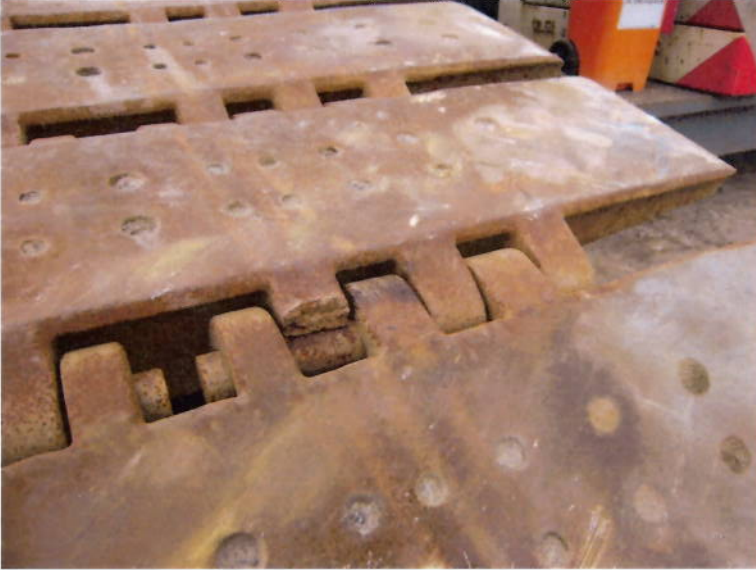
Crawlers: 1 crawler pad is partly broken (ear of pad that is around pin.)

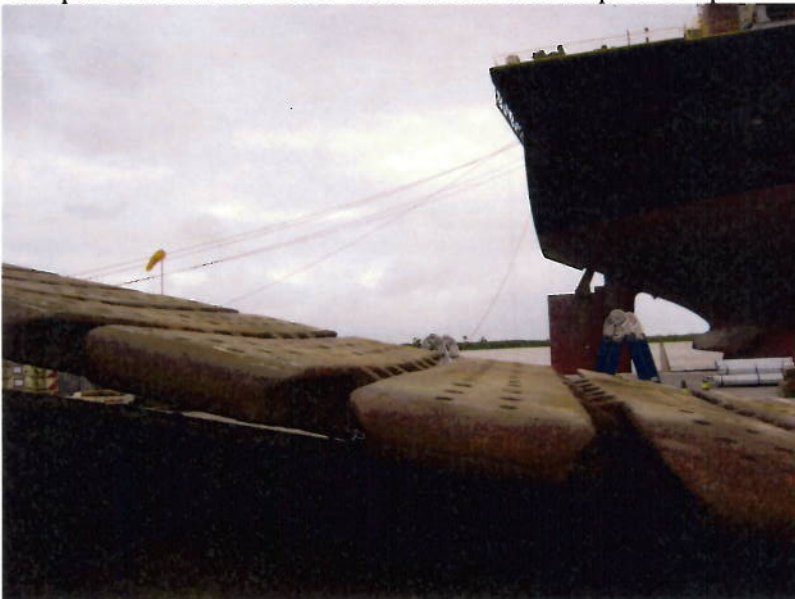
It shows a lot of wear on the pad's where the rollers are rolling on the pads it is to such a degree that the pads don't rotate properly on the pins.

the pads are also sort of bent whit outside points up

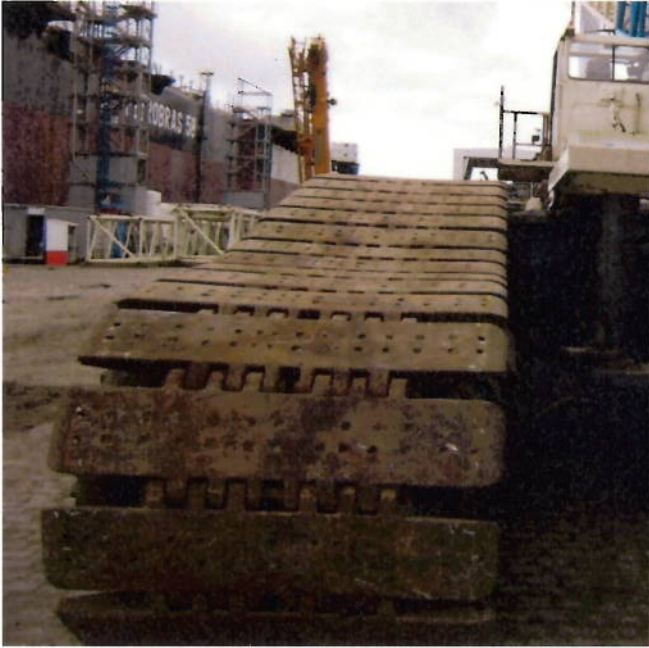
one can see that better on the below picture

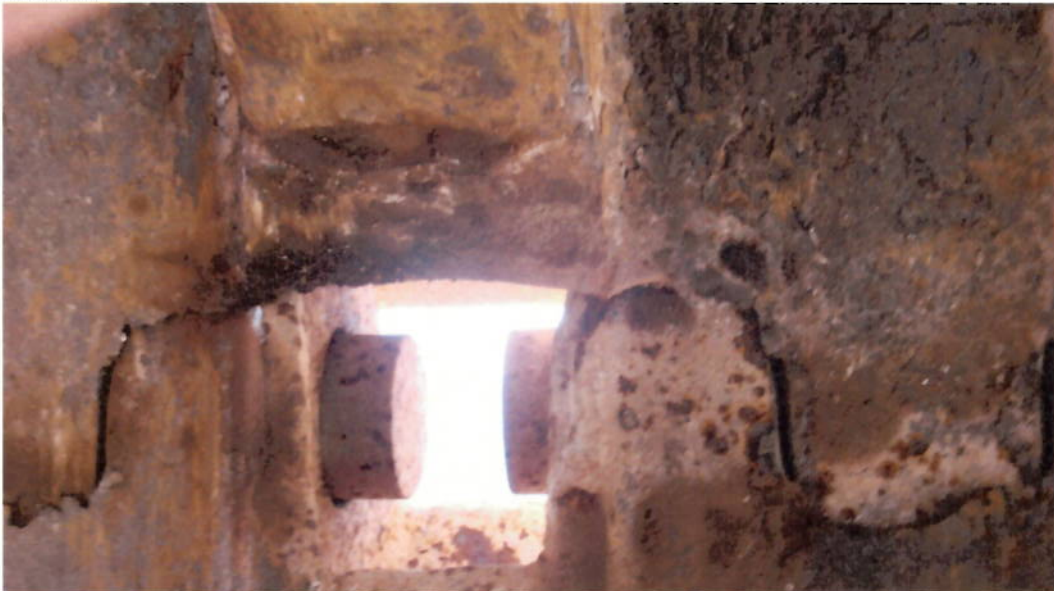
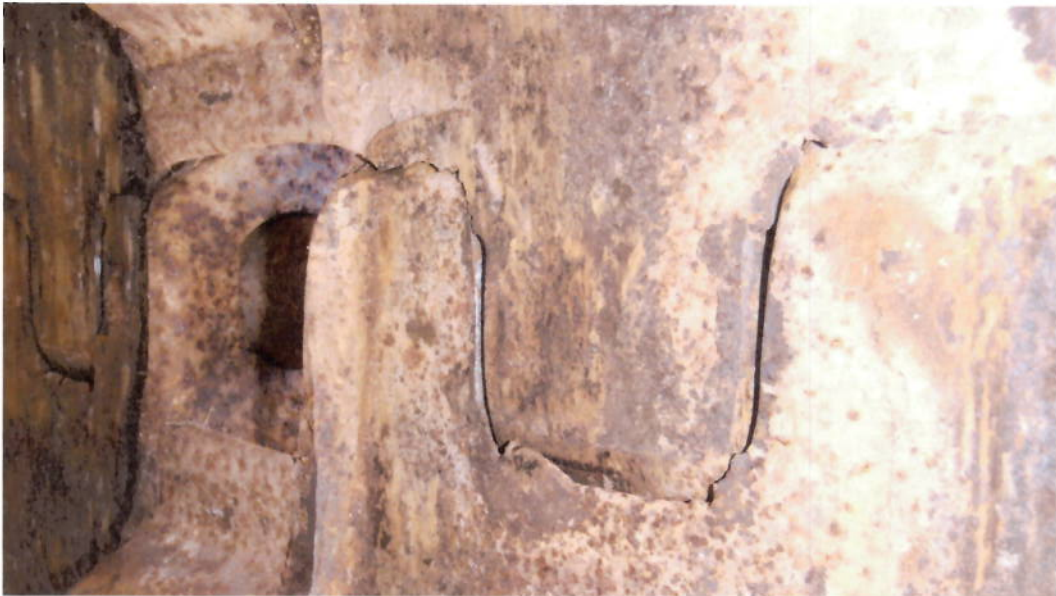
there is a lot of wear on the pads where it rolls over the rollers

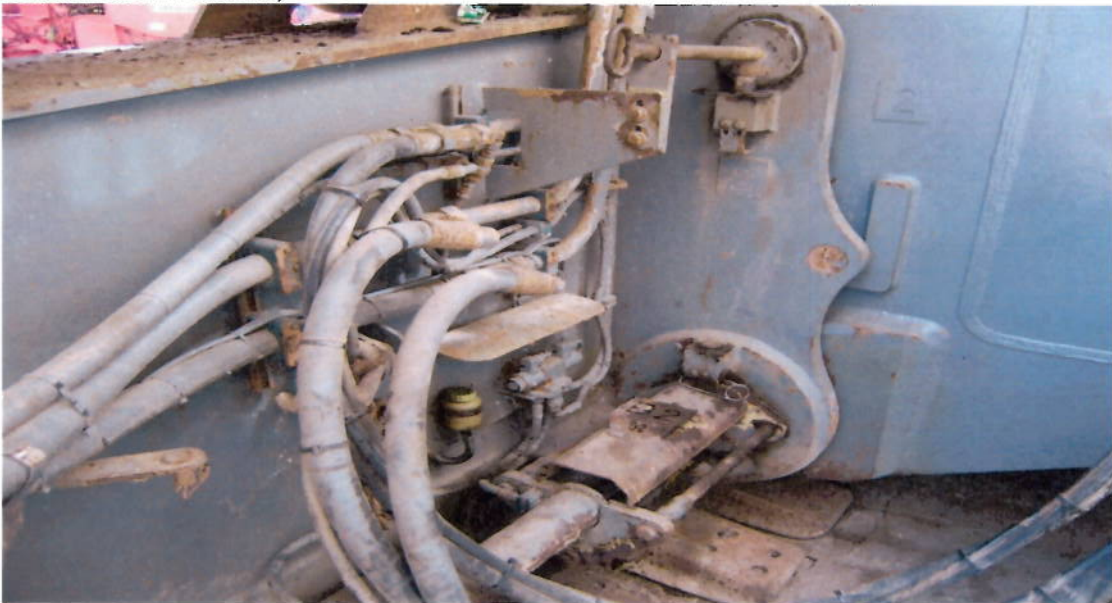
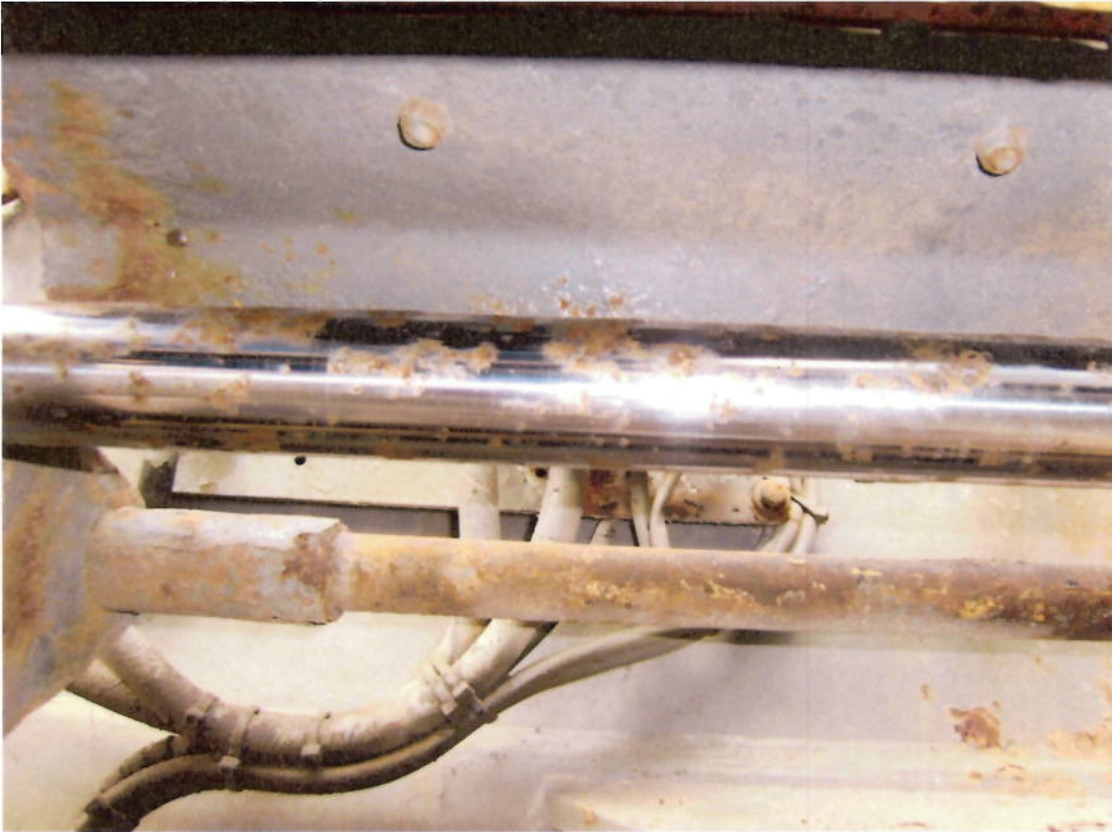
There is a lot of rust on crawlers chasis, metal parts of Hydraulic connections and electric connections,

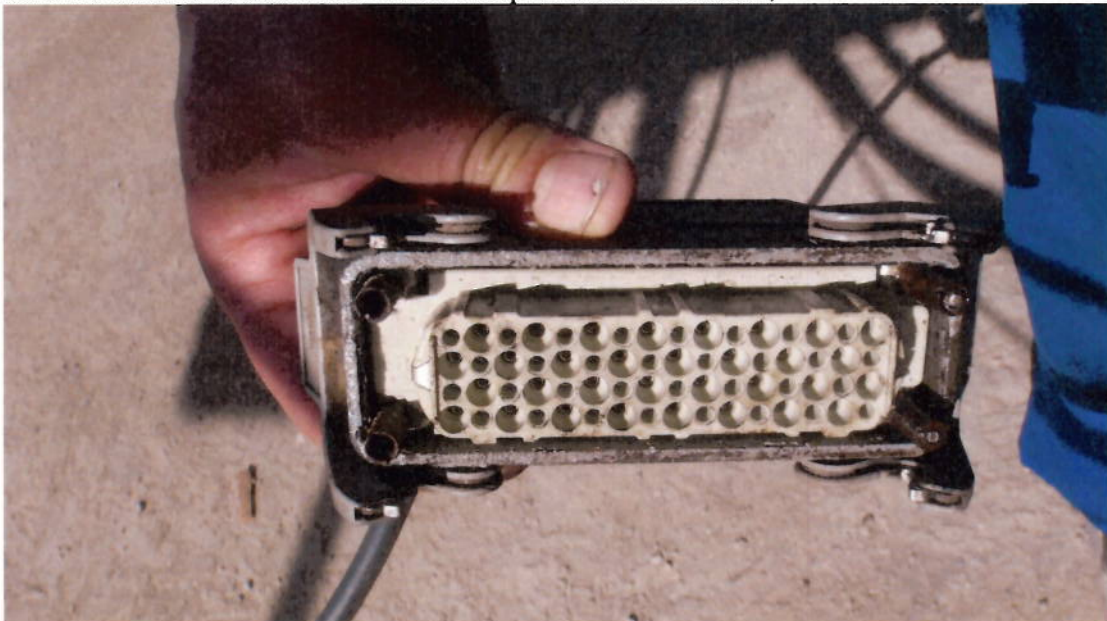
The Carbody appears to be in good condition slewing quick connection works good, again electric connections sockets are showing lots of rust and many screws tend to break when want to open the connectors,

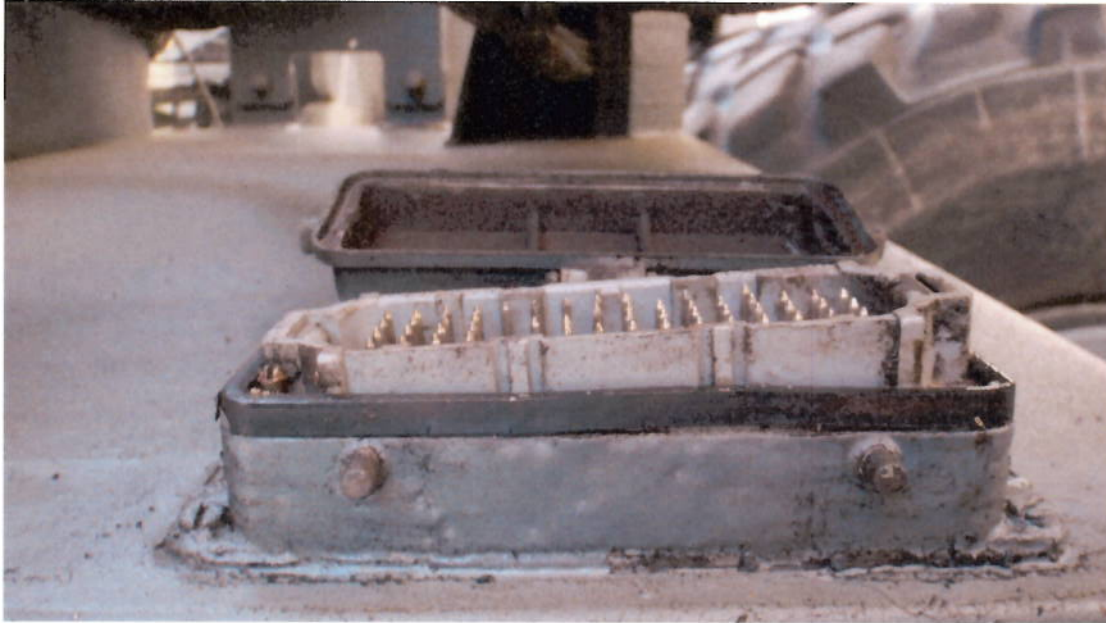
The upperstructure again rust in many electric connectors, the engine leaks coolant(minor) and the gear box sweats oil (minor) levels are good. The Hydraulic tank also leaks (minor) and remote control for assembly is not

working when open the electric box on carbody of remote control all screws broke off the Leibherr mechanic is very sure that there is the problem whit the remote control new box is advisable

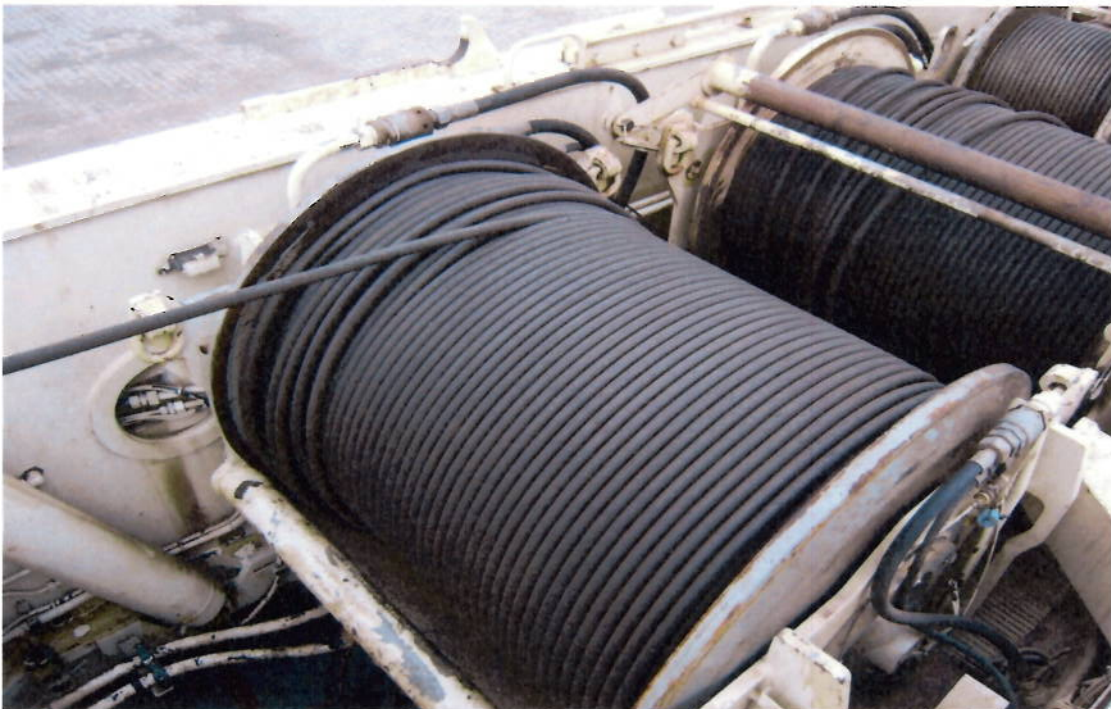
The hoist cable of Hoist WI appears to be original length but when rolled off looked like a sort of culled(wokkel) when going up in to luffer, this is a sign that the wire had it's best time on the picture below drum on right side of picture it shows that WII is a lot shorter then WI

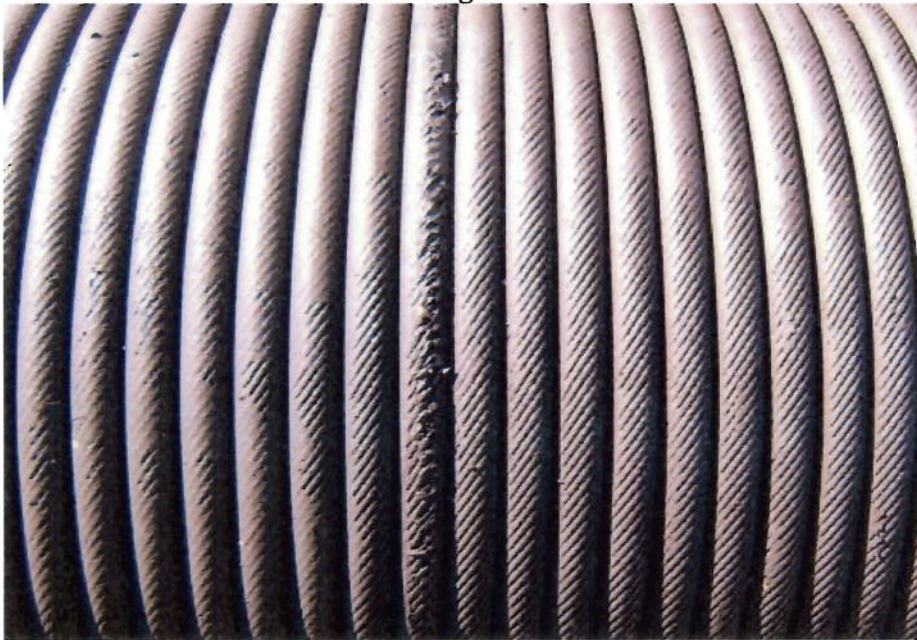
WII hoist 2 showed several damages

and is a lot shorter thus when used together WI + WII for double hook operations this makes it impossible (Leibherr mechanic mentioned to me that it is perhaps original length from factory is shorter depending on how client bought the crane originally)

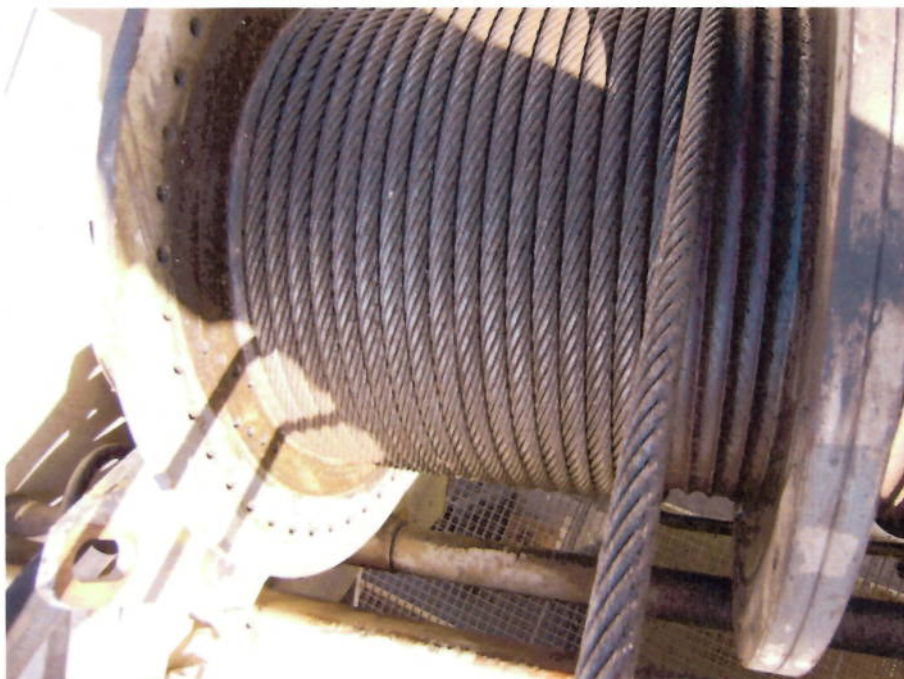
W4, A-frame wire is in good condition

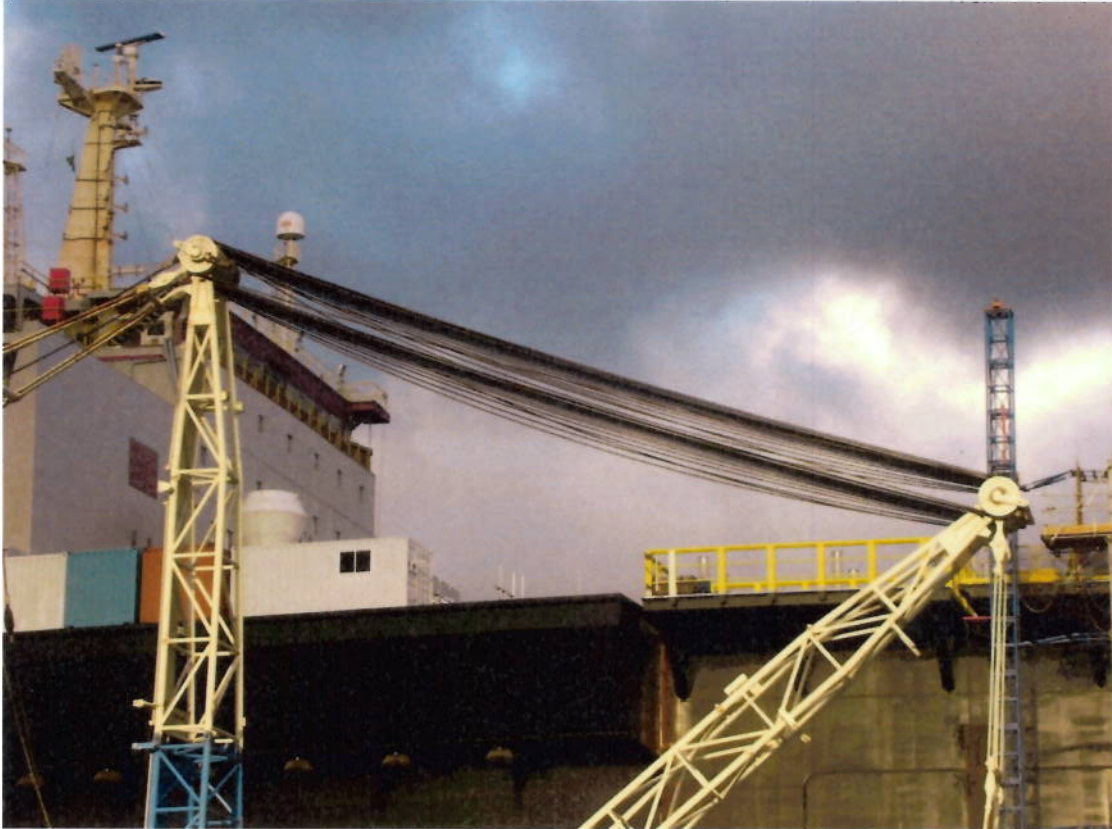
W5 luffer winch is new but doesn't look like it is an original wire and is very sturdy which makes it not easy to assemble luffer (as we have found out in practice)

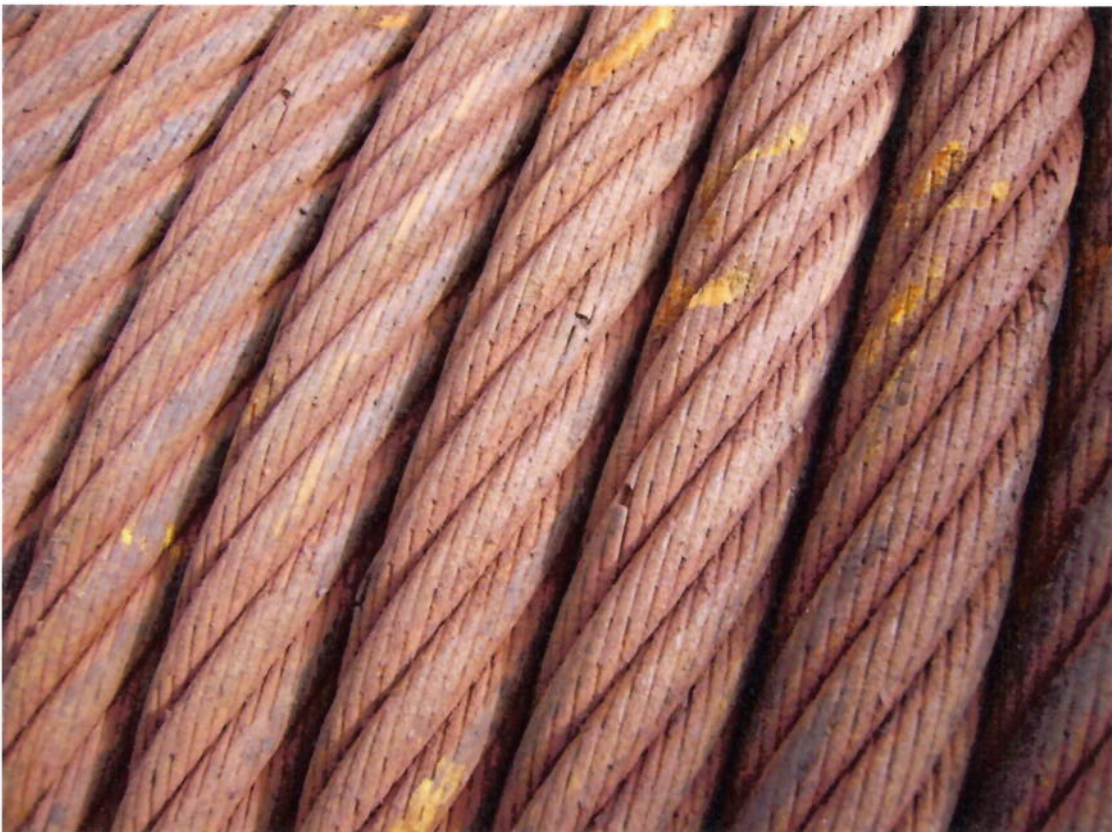
WIII the Derrick wire needs to be replaced

Works carried out:	Pending	Settled
- check everything what is not real in a nice condition		
→ Remote control receiving box do not activate the relays for the boom - SA-Derrick and crawler-pins → the wiring is okay		✓
→ cable on winch 3 cannot be used in case of much corrosion many strand are broken and the gear of the winch leaks oil at the right side → will be repaired		✓
→ crawler pads slide a lot but they can be use still		✓
→ badfall cyl. of SA, Derrick, jacks from the SW and for the crawler pin are corrosion on the red side (very much)		✓
→ cable of winch 1 is twisted and the cable of winch 2 is 2 layer stronger than winch 1		✓

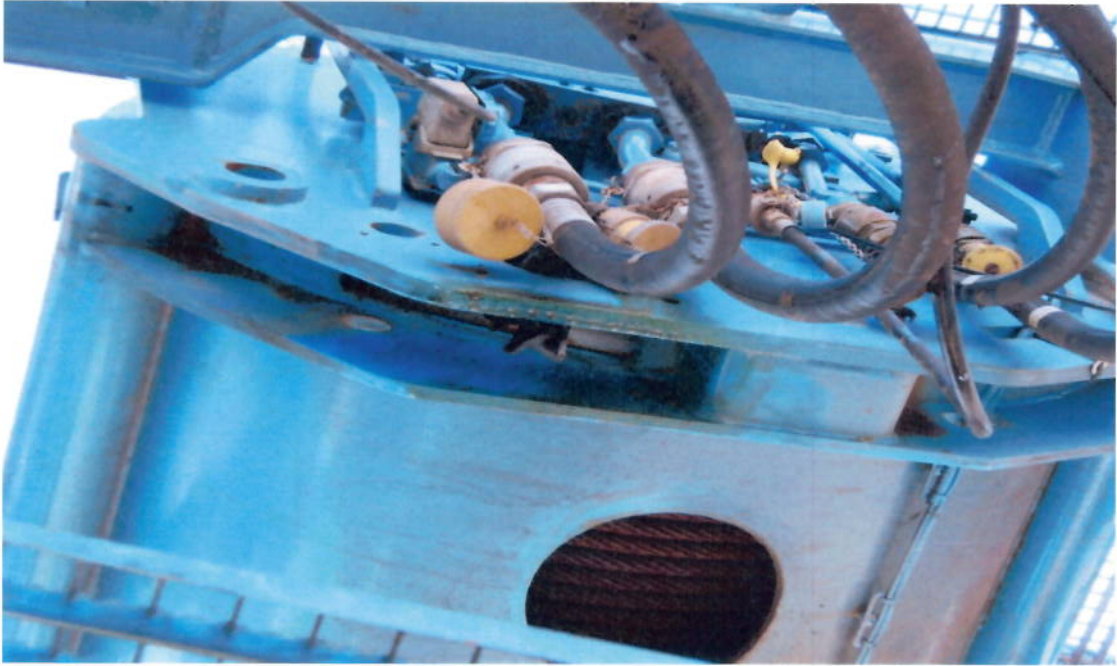
Derrick mast WIII de Derek winch is leaking oil from the gear box,

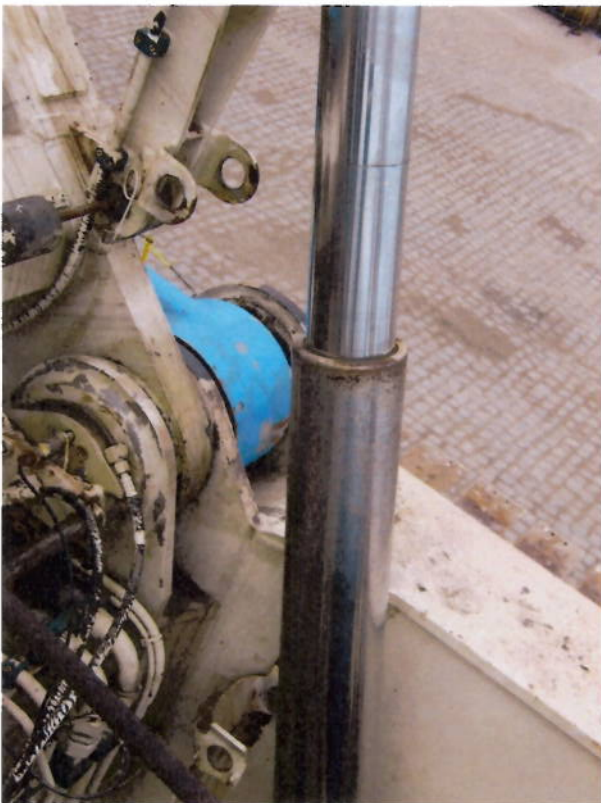
The Upper structure in general looks and works good all controls in cabin where working there was rust on the chrome of both hydraulic A-frame cylinders.

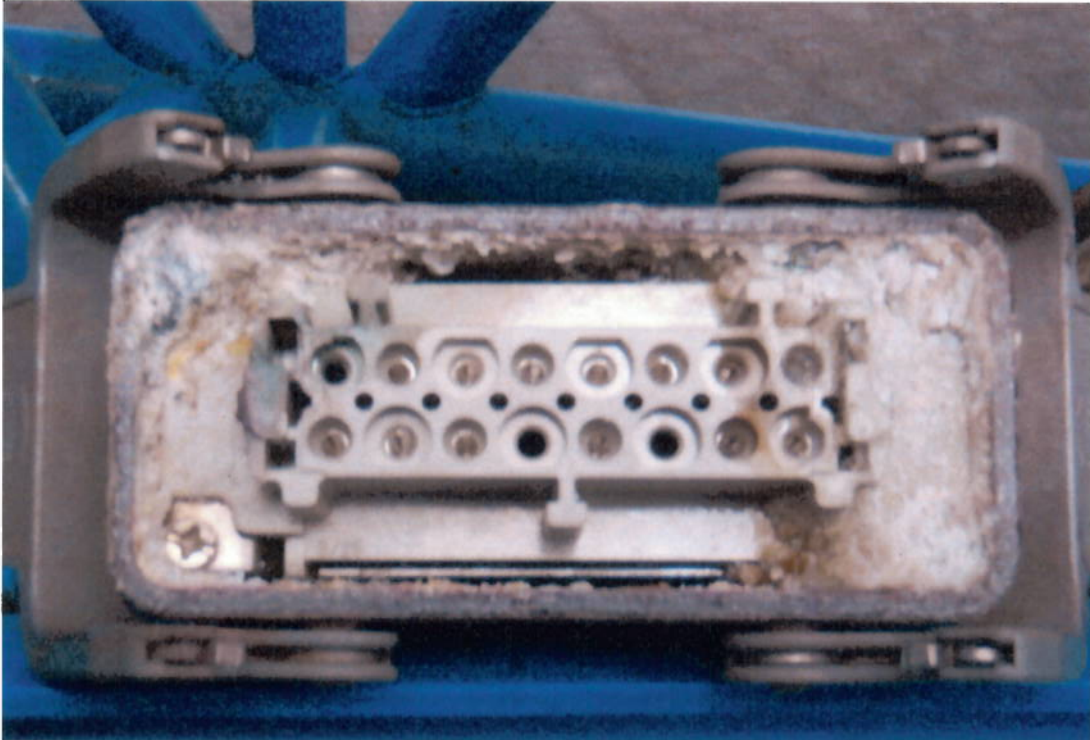
Again rust in many connectors, the engine leaks coolant(minor) and the gear box sweats oil (minor) levels are good. The Hydraulic tank also leaks (minor) and remote control for assembly is not working when open the electric box all screws broke off

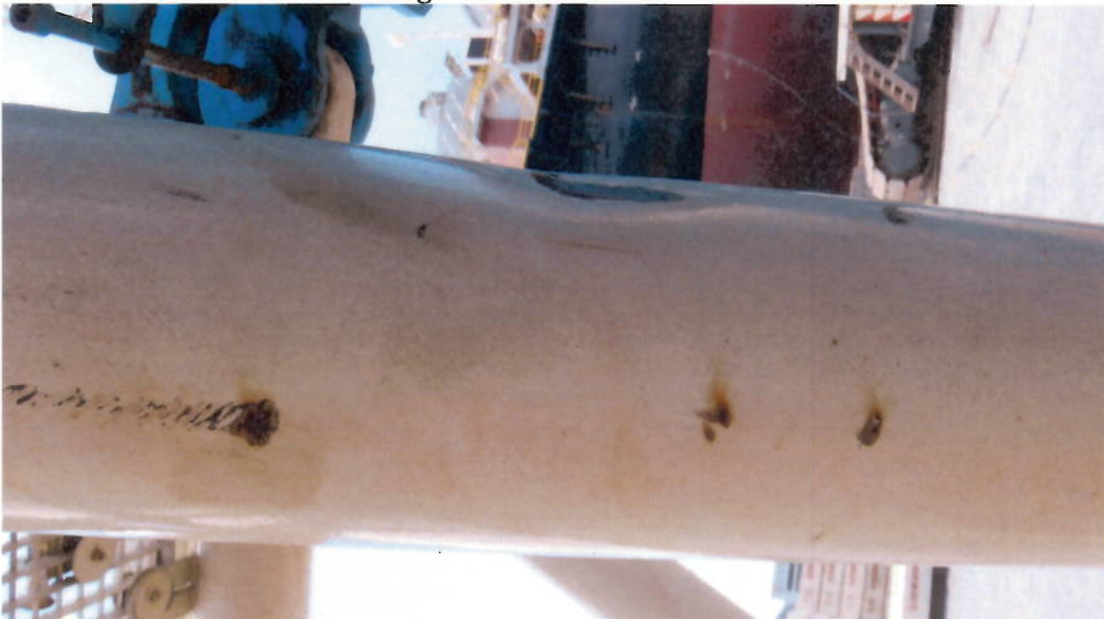
There is a small dent in a lacing in root section of the derrick mast

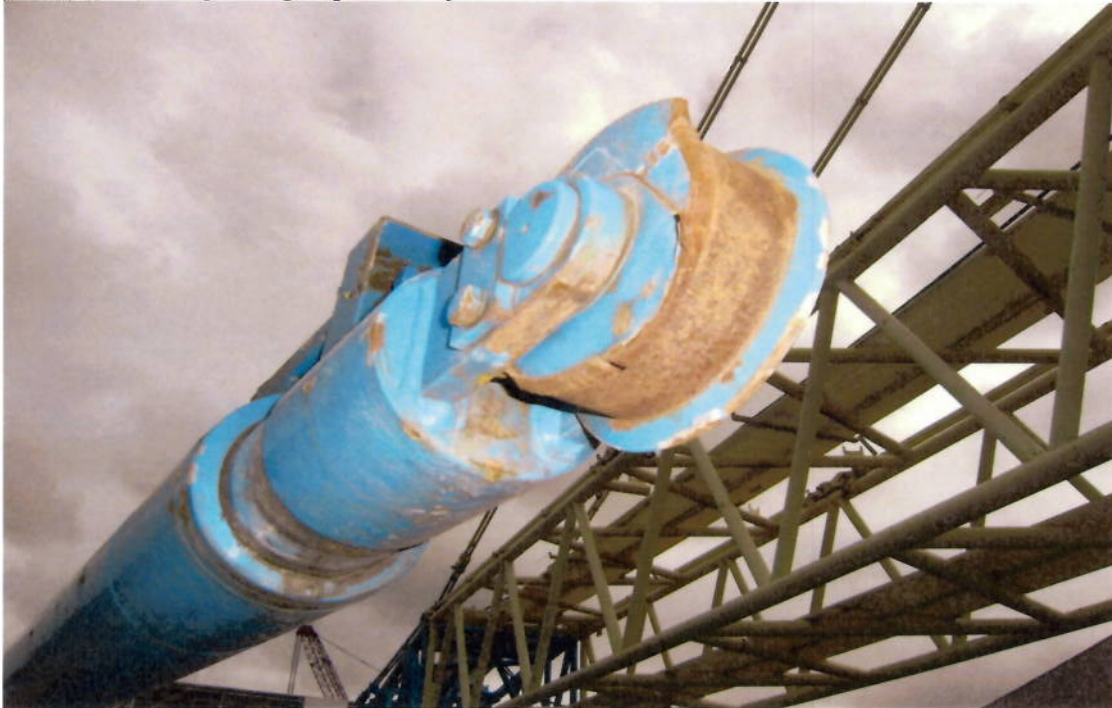
There is minor rust on the chrome of the derrick boom one damaged roller (was taken out and getting repaired by Liebherr)

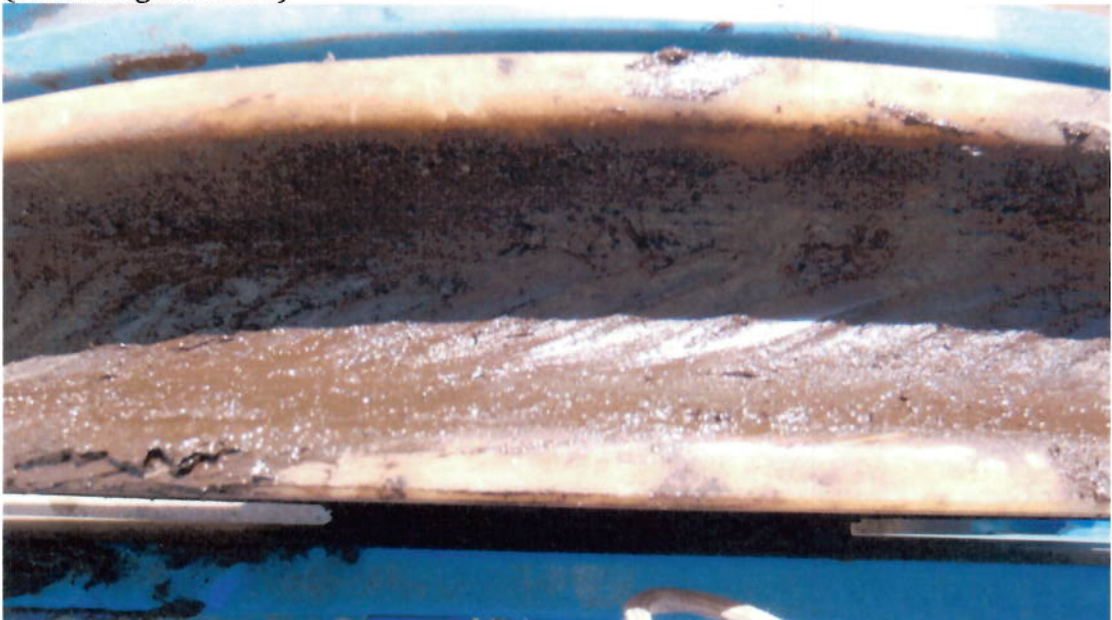
Sheaves of Derrick mast showed a lot of wear of the derrick I changed that whit a sheave from one of the runner attachments. Other sheaves where acceptable (according Liebherr)

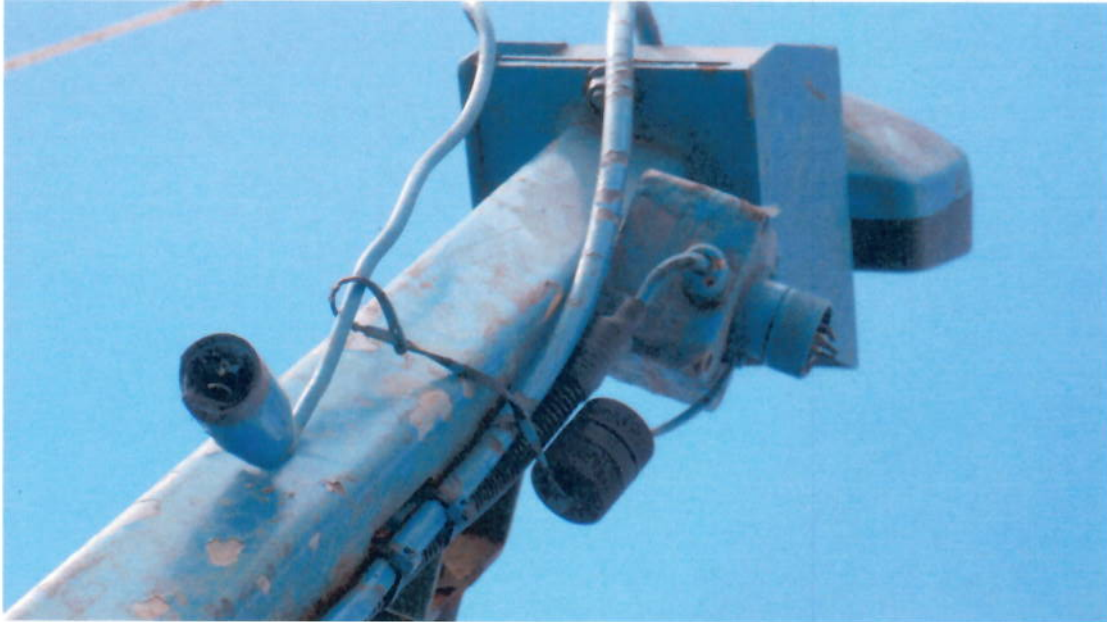
electric camera connections of the derrick is also broken at the connector

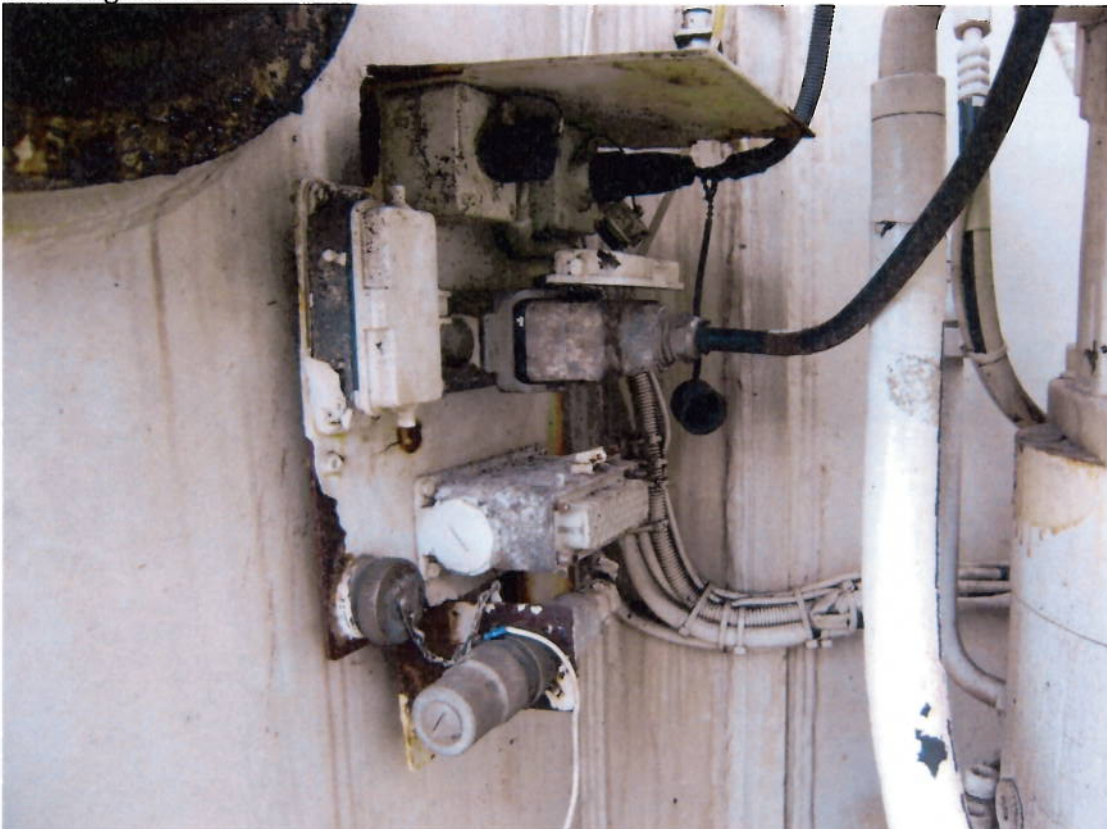
Mainboom electric connections to upper structure, again electric connections are showing a lot rust

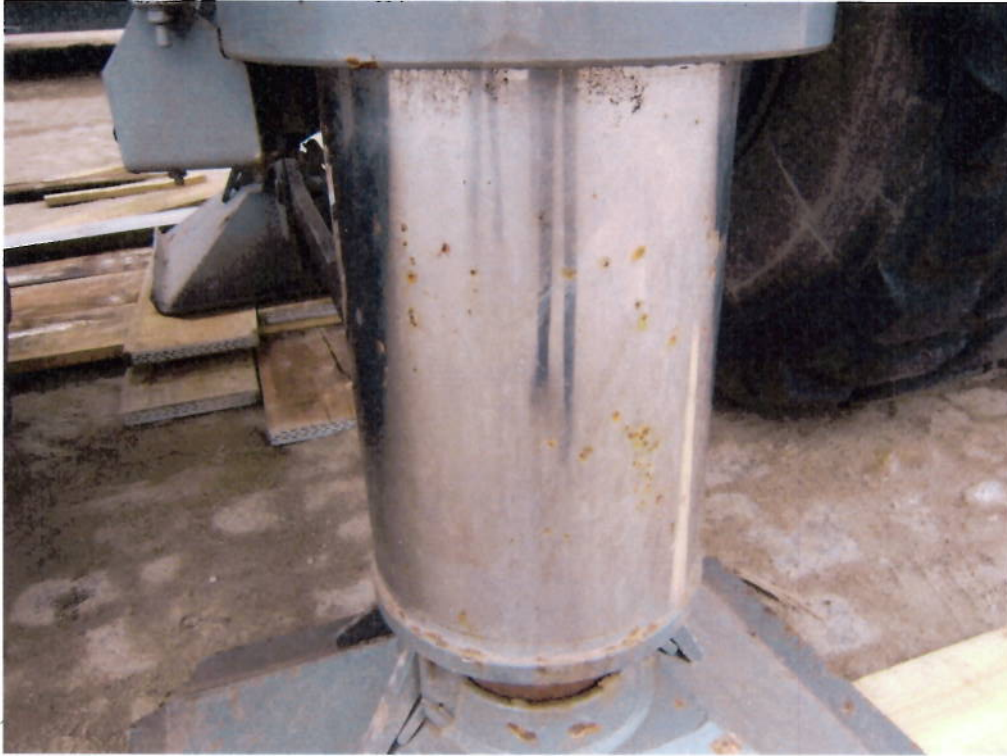
Ballast Wagon appears in good condition we had some electric problems but is all solved again connectors screws are too rusty to open and break very easy (Liebherr fixed it) we attached work all fine, some rust on the jacking cylinders of the ballast wagon

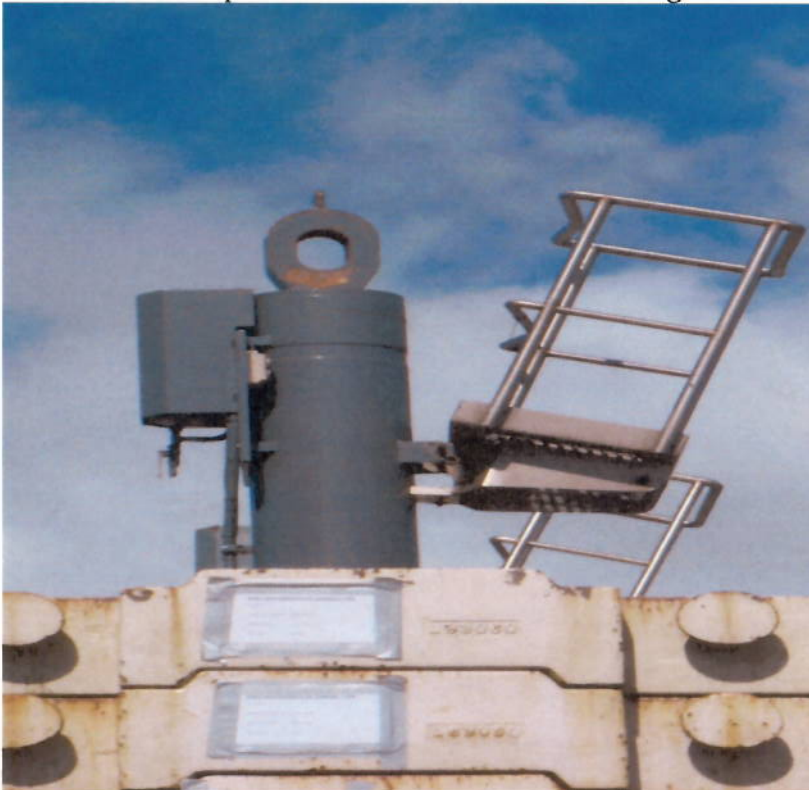
And some of the ladders (assembly cages where damaged and couldn't be used to connect the straps of back mast to the ballast wagon cylinders
